Defect Set 6 - Flow Loop Defects Load-Time-Deflection Plots

Failure Analyses

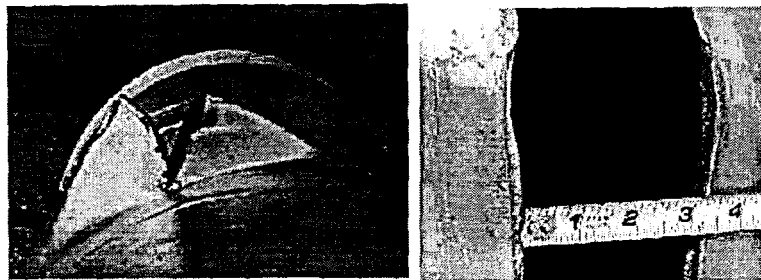
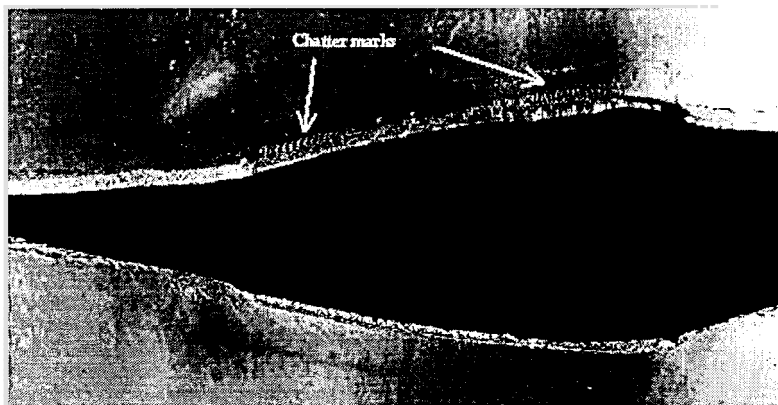
The figures at right show one of the failed pipes. The initial mechanical damage is a 6-inch long gouge located in the center one-quarter to one-third of the failure. The gouge includes the "chatter marks" in the lower figure and the region between the chatter marks. The fracture origin is a crack along the gouge and is most clearly seen in the lower photo.

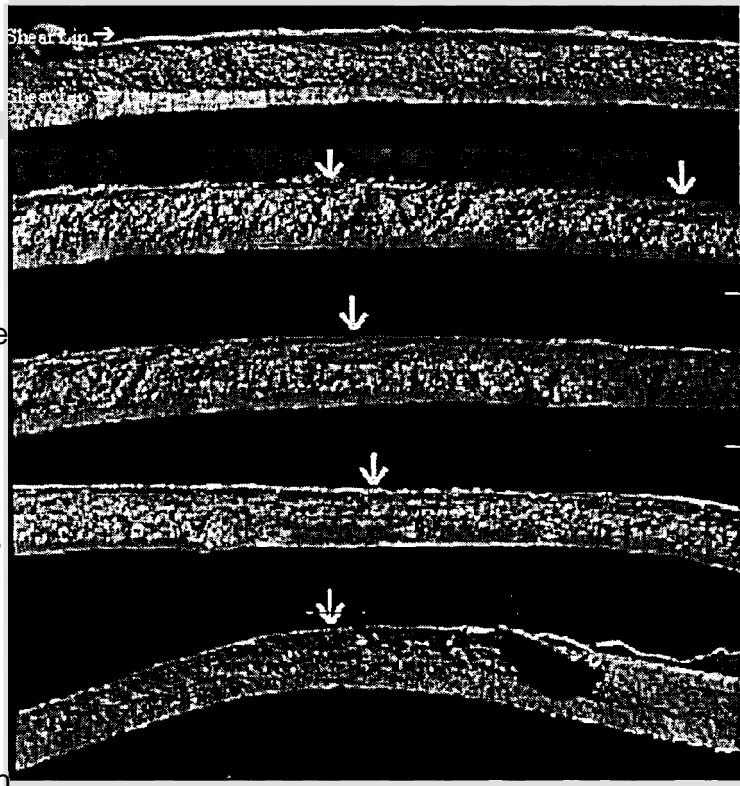
In both failures the initiation cracks occurred over the entire length of the fabricated gouge. The figure at right gives a sequence of views, each showing a segment along an initiation site. The top picture begins at the start of the left chatter mark in the above figure, and the bottom picture ends at the end of the right chatter mark. All five photographs when matched end-to-end comprise the entire fabricated gouge.

The two failures show shear lips along both the outside and inside diameters (the initial crack and the final fracture). Close examination of the fracture along the outside diameter shows the presence of different textures and colors in

addition to the shear lips. Occasionally, thumbnail-like features are clearly visible without a microscope. For example, in the third view down, an arrow points to an arc-shaped feature that penetrates into one-third of the wall thickness. Other similar, less-well-defined features are indicated by white arrows.

The thumbnail features correspond to local crack initiation sites along the shear lip. A number of shear cracks formed as the pipe rerounds. As the indenter moved down the pipe, the initiation sites merged, leading to the shear lip. Photographs taken at higher magnification and at different angles show many such features along the outside shear lips.

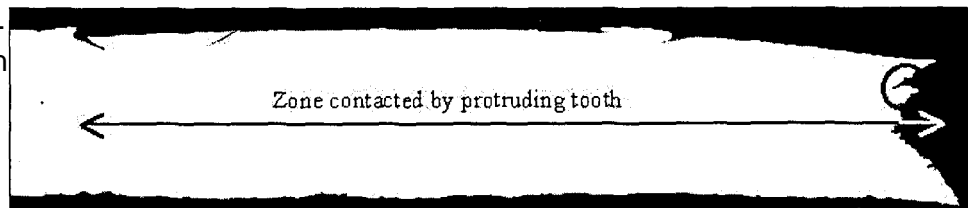
A typical cross-section through the failure is shown at right. This as-polished view

shows the entire cross-section of the gouge and corresponds to a location near the beginning of the damage. (With reference to the top figures, this section lies near the left chatter-mark.) Steel ploughed to the side of the contact area by the protruding tooth

can be seen near the crack at the left edge of the cross-section. The small difference in wall thickness on either side of this crack illustrates that the gouge depth was small.

Shear cracking is evident at the failure plane and at the opposite corner of the indenter. Shear cracking is also evident elsewhere across the gouge. At some sites, cracking develops along both shear planes. Hence, multiple initiation sites were formed by the indenter, and these initiation sites are *not* associated only with the stress concentration caused by the sharp edges of the indenter.

The deeper shear cracks also show evidence of opening perpendicular to the crack, indicating the presence of tensile stresses across the crack plane in the hoop direction. These stresses act in addition to the shear stresses, which lie parallel to the direction of shear-crack growth at approximately 45 degrees to the pipe's surface. The significance of the crack opening is discussed below.

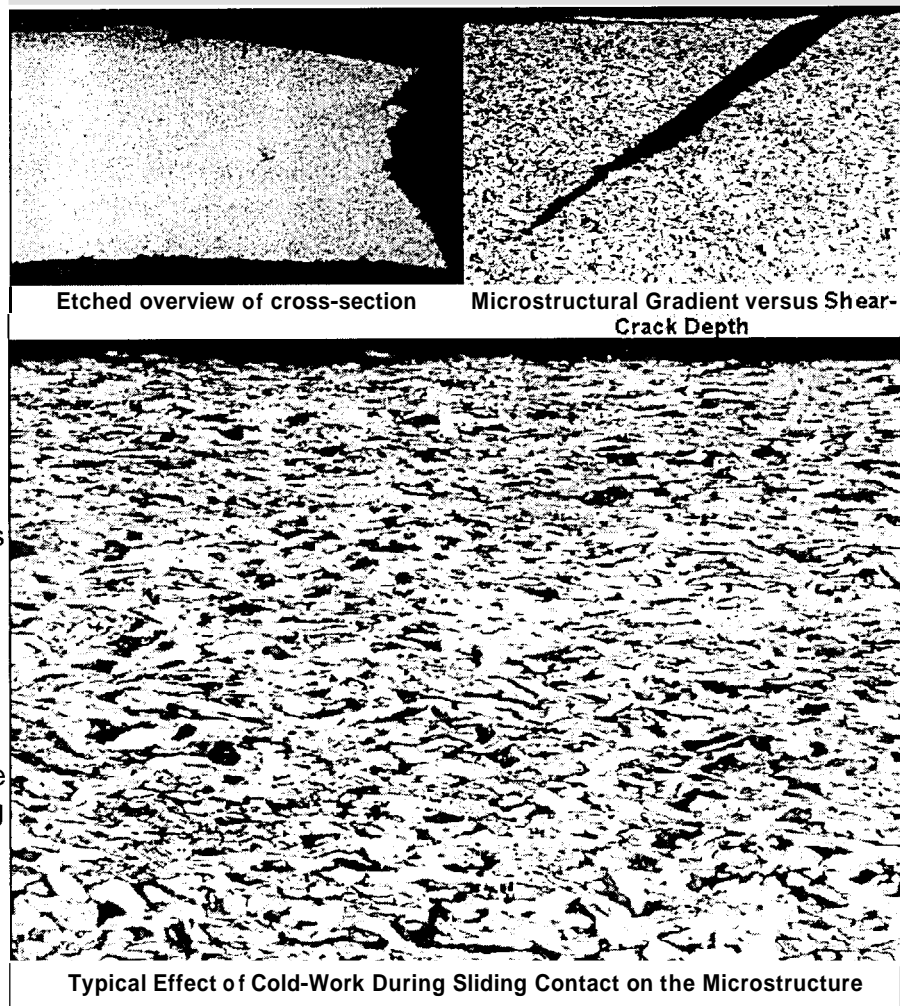
Presumably, rerounding created conditions that exceeded the local initiation resistance of the material. The figure at right shows the effects of the indenter sliding along the pipe surface. Sliding caused a "pancaking" of the microstructure. (The view shown is along one of the deeper shear cracks.)

at these locations involves flattening and elongation of the microstructure. There is no evidence of transformation driven by localized heating from contact being quenched by the heat-sink of the unworked steel. (Surface transformations have been seen in some field failure investigations.)

The axial and radial dimensions of the grains below the pancaked layer are roughly equal. That is, there is no preferred orientation of the grains as might be seen in a heavily controlled rolled steel. Near the outside diameter, the grains are extremely long and narrow. Along most of the shear crack, they are elongated to a lesser degree. Near the tip of the crack and below, they return to the original state.

The local strains required to pancake the grains are much larger than those associated with denting or similar geometric changes. They easily reach several tens or hundreds of percent. In addition, the straining is highly anisotropic. These strains and distortions determine the local resistance to crack initiation, and they indicate severe damage.

There is a steep gradient in the hardness of the pancaked grains caused by cold working. Hardness measurements were taken at several locations across and through the pancaked layers. In the undisturbed microstructure, the hardness values ranged from Vickers 200 to 220. Near the surface, some of the hardness values exceeded Vickers 300. At 5 percent depth, the hardness values were typically near Vickers 260, while at 10 percent depth, the values were slightly above the undisturbed hardnesses.

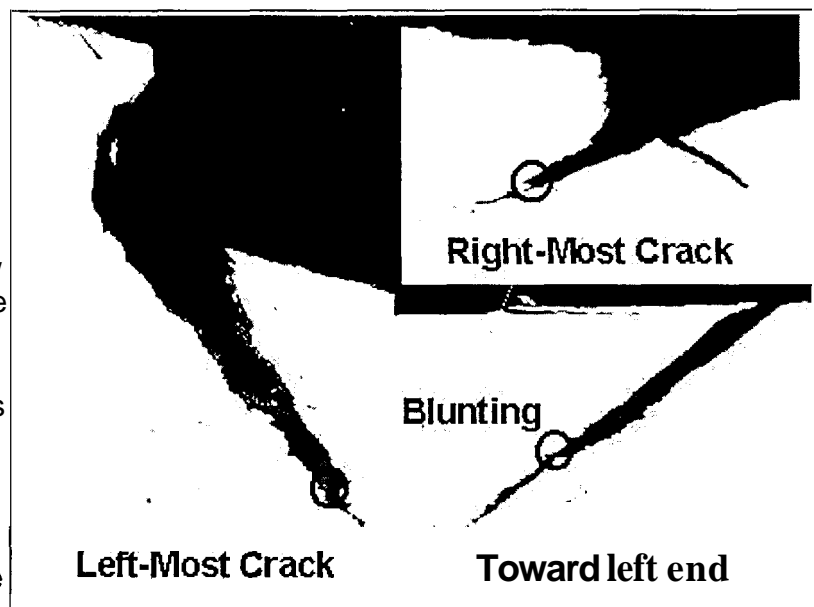
Detailed as-polished view: of a typical cross-section are shown at right. These views confirm that the cracks initiated in response to shear stresses, but they also show that the cracks grew and coalesced under more complex loading. The deeper cracks show regions along their lengths for which the crack opening varies. Such differences in opening correspond to stops and starts in crack growth, due

The largest shear cracks for the two failures extended about 10 percent into the wall thickness, which is the depth of the pancaked region. By the time the cracks reached this depth, void nucleation was occurring around the crack tips. Prior to this time, the cracks initiated and grew intermittently by shear or mixed shear/void nucleation and coalescence. **As** the cracks approached the end of the pancaked region, their growth mechanism transformed from shear to void nucleation and coalescence, and they turned and extended by stable tearing. For this to occur, the loading must have been sufficient to generate large hydrostatic stresses. (At the surface, void nucleation and hydrostatic stresses cannot be generated because the surface stress is zero.)
